Manhole Inspection Summary

Manhole # S35YY1013MH

Location Address: **310 SAINT DUNSTANS RD**

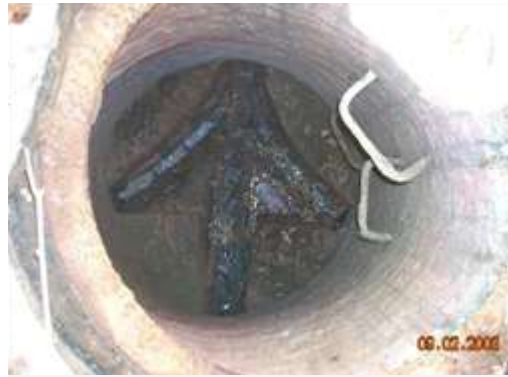
Top View

Evidence of surcharge - Bench debris.

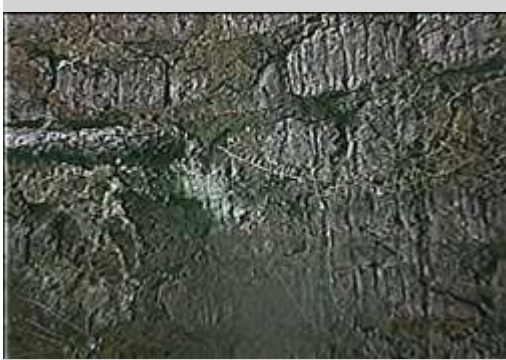
Defect

Corbel deterioration, root intrusion and infiltration.

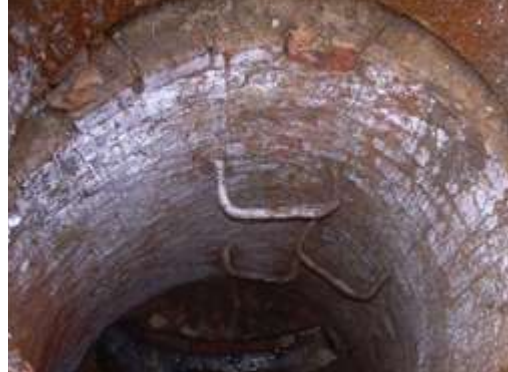
Defect

Frame offset. Adjustment deterioration, loose brick and infiltration. Corbel infiltration - other side.

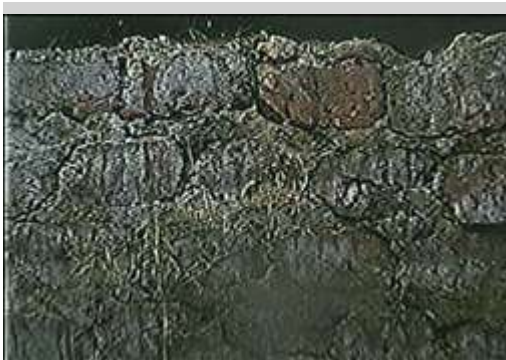
Defect

Adjustment deterioration, root intrusion and infiltration.

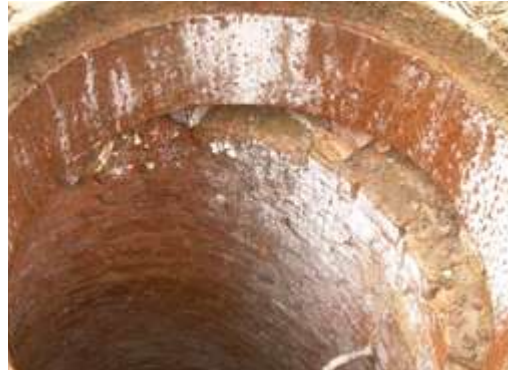
Defect

Frame leaks. Frame offset. Adjustment deterioration, loose brick and infiltration. Corbel deterioration and infiltration.

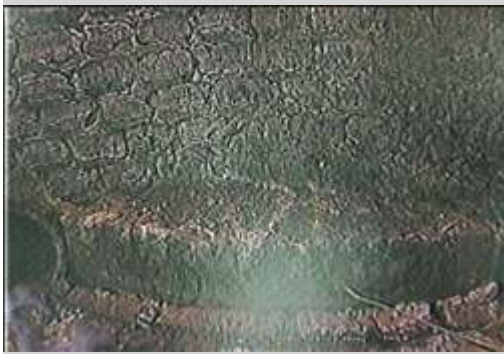
Defect

Barrel deterioration and infiltration.

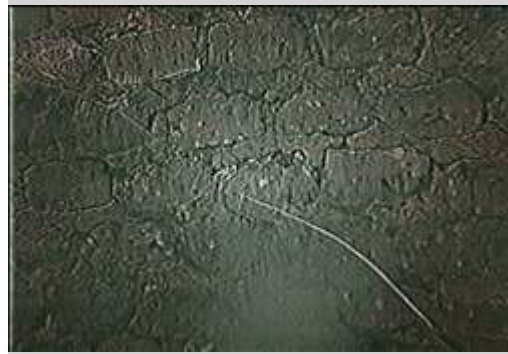
Defect

Barrel deterioration, root intrusion and infiltration.

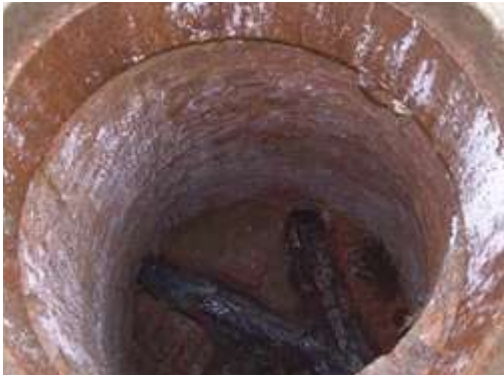
Defect

Adjustment deterioration and infiltration.
Corbel and Barrel infiltration.

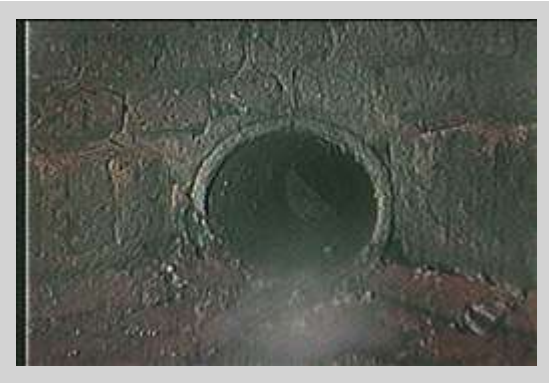
8 in. Circular Gravity Sewer Pipe Out @ 12 O'Clock

Barrel deterioration and infiltration. Channel deterioration.

Infiltration: **Evidence** Pipe Seal Cond: **Roots**

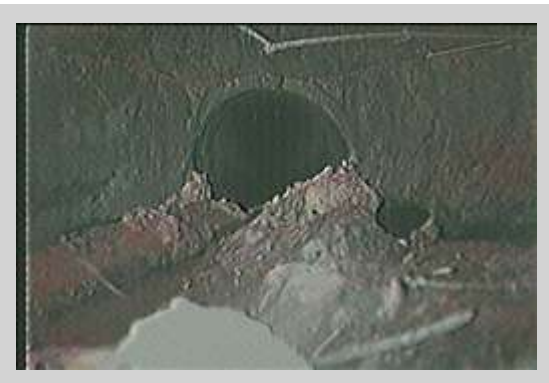
6 in. Circular Gravity Sewer Pipe In @ 4 O'Clock

Channel debris and deterioration.

Deposits: ☐ None ☐ Mud ☐ Sludge ☒ Debris ☒ Grease

Silt Depth: **1** (in.) Deposits Extent: **Light**

Infiltration: **Evidence** Pipe Seal Cond: **Unknown**

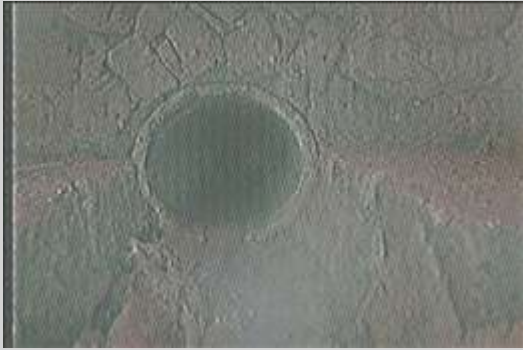
Pipe In @ 6 O'Clock

Barrel deterioration and infiltration. Channel deterioration and root intrusion.

Infiltration: **Evidence** Pipe Seal Cond: **Broken**

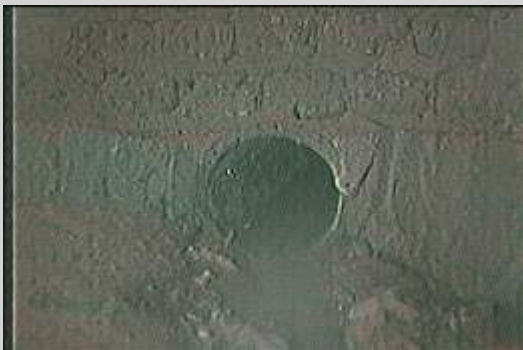
Pipe In @ 8 O'Clock

Barrel deterioration and infiltration. Channel debris.

Infiltration: **Evidence** Pipe Seal Cond: **Unknown**
